Newtownstewart and Sion Mills- Heritage Audit

Heritage Tourism and Environmental Consultants (HTE) have been commissioned by Derry City and Strabane District Council to undertake a heritage audit of the settlements of Sion Mills and Newtownstewart, Co .Tyrone.

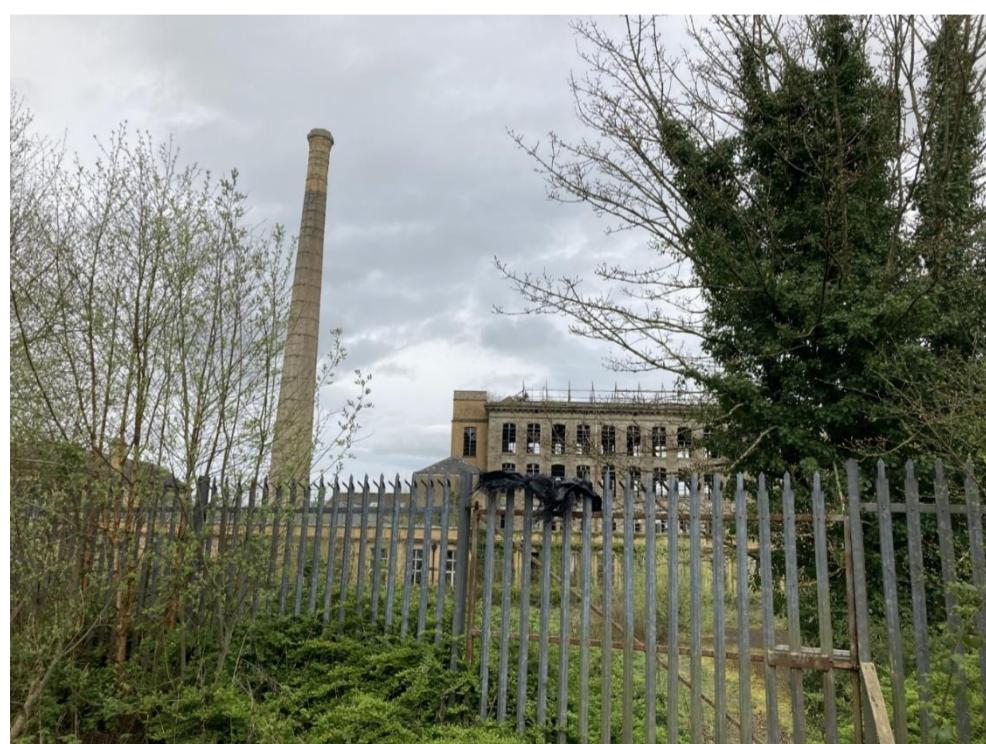
Picture 1 : The disused Herdmans Mill

The mill complex is situated on the west bank of the Mourne River, within the village of Sion. The main entrance lies roughly to the south west corner of the site and is sandwiched between the large 'main mill' grouping (to the north west) and the admin. block (to the south east). It consists of a high sandstone wall with a large elliptical arched carriage entrance with timber sheeted double doors. The wall is topped with a cornice and blocking course with 'springing course' to the arch and the date '1835' inscribed on the 'keystone' voussoirs. This gateway appears to be all that

remains of the original mill of the 1830s. To the south west of the tower is a large part two, part single storey section in yellow brick which was added between 1884 and c.1907. To the SE of the tower is a four storey gabled extension, also in yellow brick, dating from 1907. To the north west is a double gabled single storey block, mainly in red brick, which spans the former mill race and probably dates from c.1900. To the south west is a large four storey gabled section of 1907 mainly in yellow brick, which with its austere classical appearance and thick buttresses, has a Post War Eastern Bloc Constructivist feel. A.1 The original portion of the main mill is four storeys high with an attic floor and topped with a slated double pile hipped roof. The façade is mainly in light brown sandstone (which was quarried at Douglas a few miles to the south). To the west of the original mill is a large area with a bowling green and tennis court, with a small timber pavilion to the west of these. This whole area appears to have been laid out in the early 1900s. To the north is a cricket pitch, laid out c.1864, and football pitches of more recent vintage. Far to the south (on the Mourne River) is the weir which was originally constructed for the pre 1832 corn mill, but has been much modified in more recent years.

There are currently a number of complex legal issues surrounding ownership of the Mill and access to the site. Sion Mills Preservation Trust have completed a 'Masterplan' for the site and are keen to restore the Mill to its former glory including restoration works to the turbines and weir. The group would also like to extend the current Mourneside Walk up the river bank to the old railway bridge (adjacent to Camus Church & Graveyard) and provide access to the 'Holm Field' which previously provided recreational and sporting facilities for the mill workers and village residents.

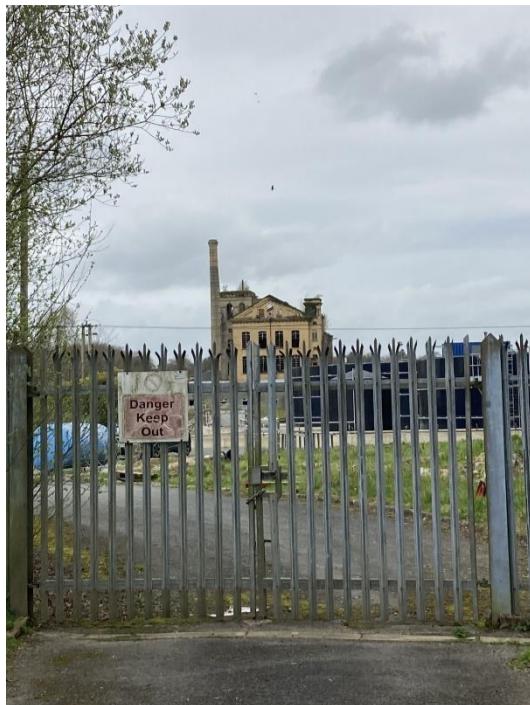
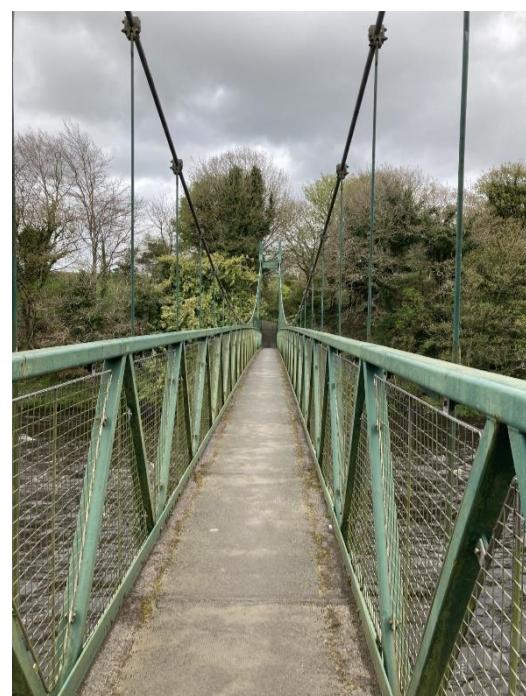
Pictures 3 & 4 : Panoramic view of Herdman's Mill from the Mourneside Riverwalk and The 'Swinging Bridge'

One of the most important reasons the Herdmans chose this site for their mill was its close proximity to the River Mourne. The Herdmans commissioned the prominent 19th century industrial engineer Sir William Fairbairn, to construct a waterpower system including the mill stream and weir to drive the waterwheels to power the mill. Derry City & Strabane District Council have developed a 0.7 miles circular riverwalk along the banks of the Mourne River, the walk skirts the perimeter of the mill and crosses the river in a few locations offering panoramic views of the 19th century weir, the old mill and the swinging bridge, originally built to facilitate mill workers. The current bridge was built in 1988 replacing earlier bridges built in 1871 and 1929 respectively.

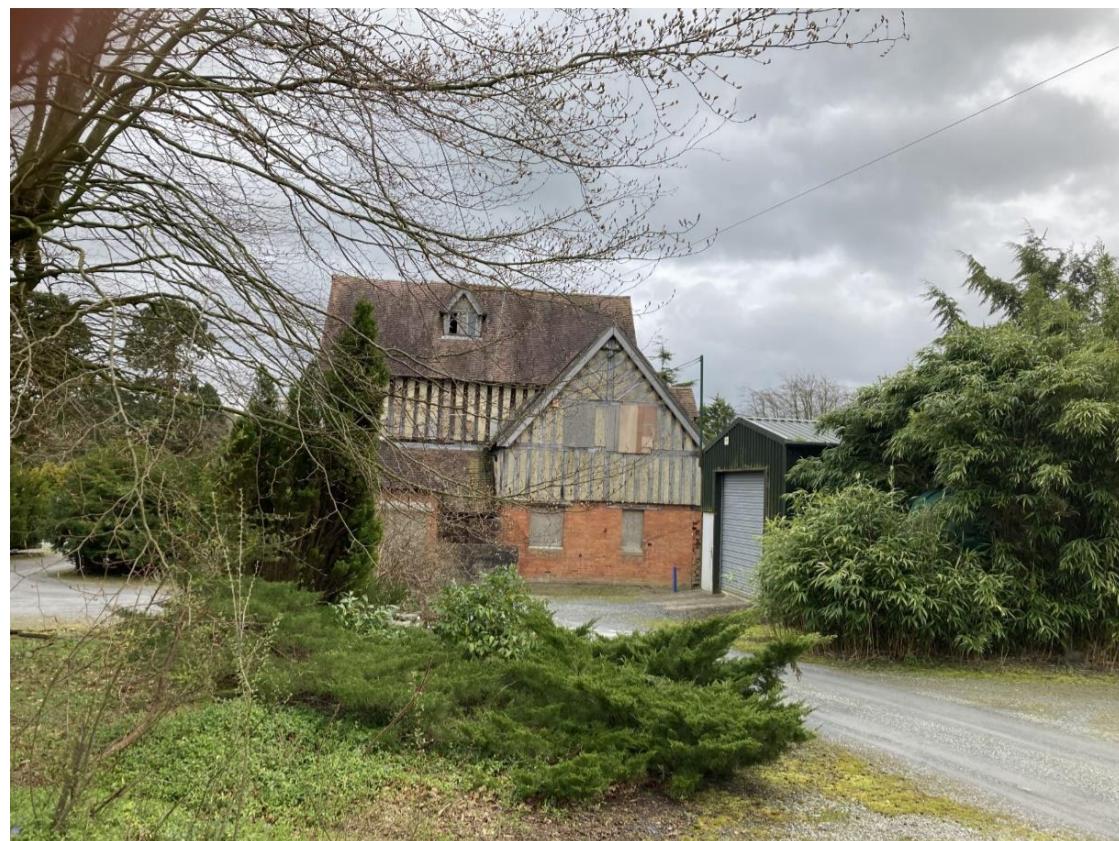
Picture 7 : Sion House

Sion House & Gatelodge were both designed in the 1840s by the architect W.F. Unsworth, the son in law of James Herdman, one of the founders of the mill and served as the home of the Herdman family. The 18 acre gardens of Sion House included terraces and statues, box hedging, a splash pool, wishing bridge with waterfall and a glasshouse. Sion House and Gate Lodge are unfortunately in private ownership at present and going into dereliction, public access does not currently exist to the house, gardens or Gatelodge. The Gatelodge is recorded by DFC Historic Environment Directorate as being 'heritage at risk'.

Sion House is a large, visually complex, mainly two and a half storey Elizabethan style 'manor house' gentleman's residence- with mock timber framing, gables, dormers, high pitched tiled roof and various single to two storey projections. The house is set within extensive grounds to the east of Melmount Road, with a matching 16th century style gatehouse over the entrance (to north west of the house itself). The property is largely finished in mock timber framing (using real timber), but with the exposed basement level in roughcast and brick, and a significant portion of the front west and rear elevations in brick also. Much of the rear (south) elevation is in poor order with a section of the basement and first floor façade having been removed exposing some rooms to the elements. A large section of the roof to this side has been lowered a storey, and a veranda, which originally ran almost the whole length of this elevation, has completely disappeared as has a conservatory which existed. Gables of various sizes predominate to all sides and the largely pan tiled (and generally chimneyless) overhanging roof is punctuated with gabled and hipped roof dormers. The window openings are largely original with many sporting leaded lights within mullioned and transomed timber frames. One opening to the ground floor front has been enlarged slightly, another close by now blocked up, and some others have relatively modern plain glazed frames.

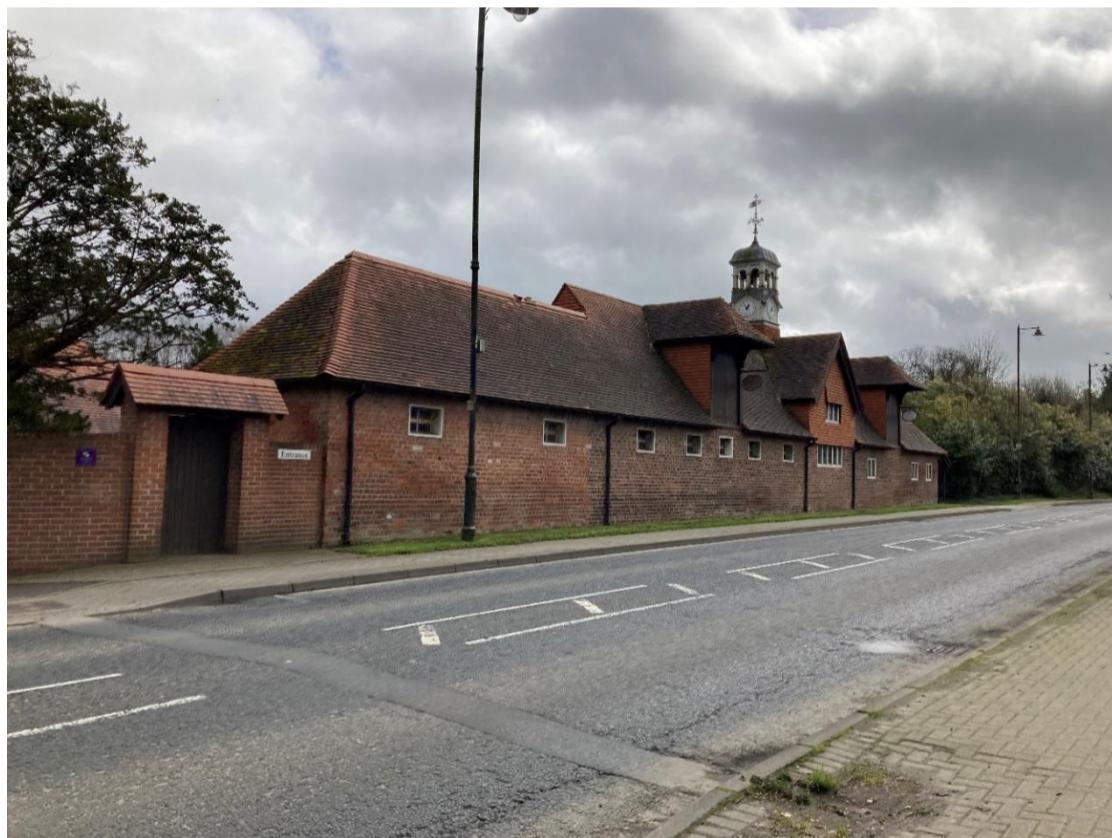
Picture 10 : Sion Stables

The stable block was built in 1884, also designed by architect W.F. Unsworth. The clock on the roof of Sion Stables was an important civic amenity and a focal point of the village. Sion Stables Museum is currently housed within the period horse stalls which were fabricated in the late 19th century by Musgraves of Belfast.

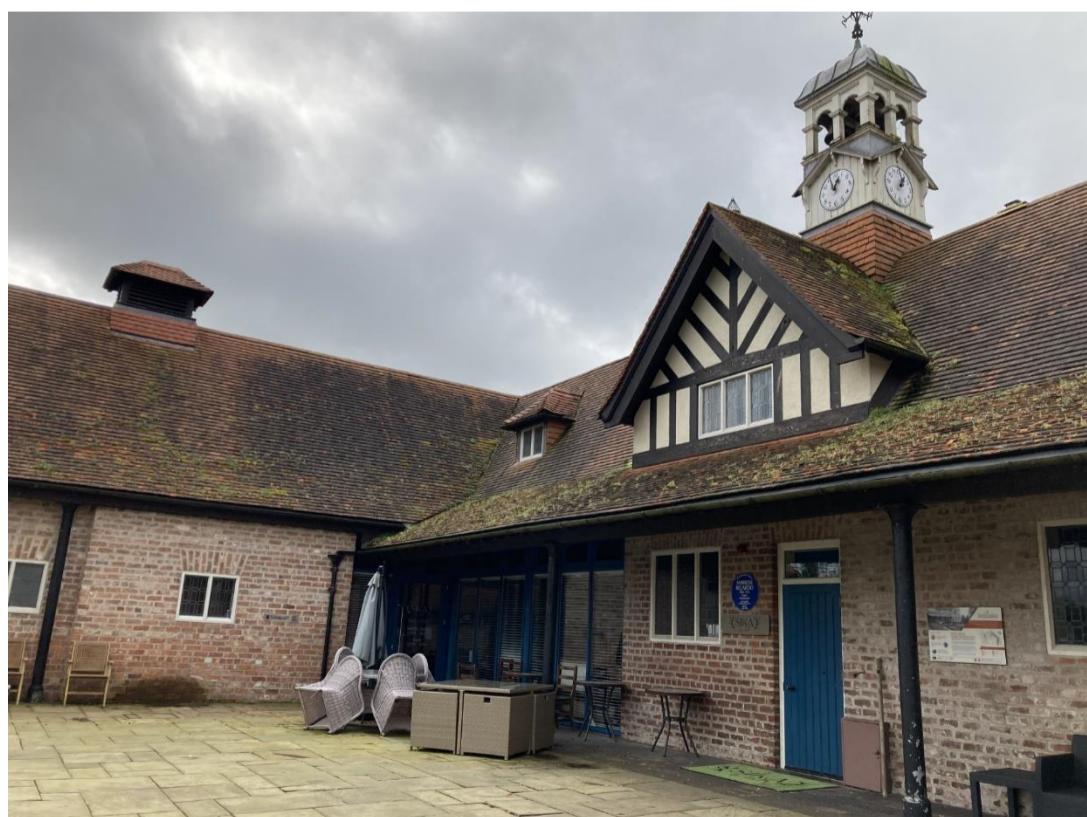
Picture 12 : The restored Sion Stables

The restoration of Sion Stables was started in 2014, funded by the Heritage Lottery Fund, the Garfield Weston Foundation, the Headley Trust, Northern Ireland Environment Agency and the NI Rural Development Programme (DAERA). This consisted of the restoration of the Stable building as a restaurant, museum and offices, along with construction of a new-build classroom to provide additional meeting space.

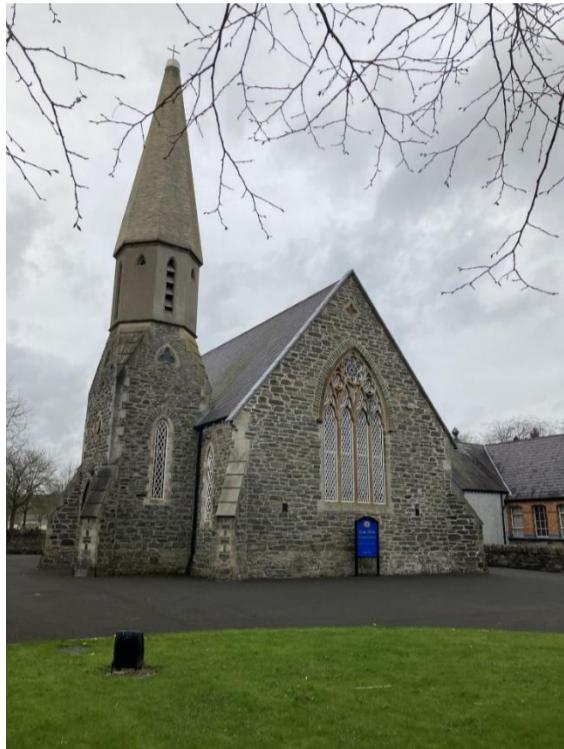
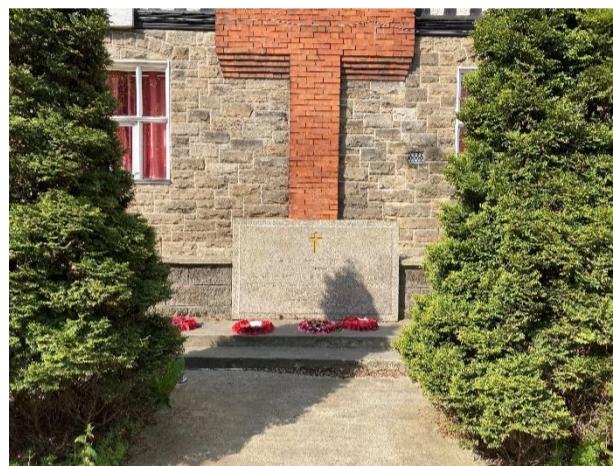
Pictures 17 & 18 : Presbyterian Church & War Memorial

A double-height Gothic Revival Presbyterian Church, dated 1866, and located on the west side of Melmount Road, in the Sion Mills Conservation Area. The church has a rectangular nave and three-stage steeple to east, and has a double-height church hall (dated 1905) attached to south; there is a single-storey porch to west (west side of hall and porch are also abutted by lean-to additions. Roof is pitched natural slate with angled clay ridge tiles, stone verges on cavetto moulded kneelers and a filigree Cross finial raised on a tapered plinth to apex; quatrefoil chimneystack to south gable; ogee cast-iron rainwater goods on corbel blocks. Walling is random coursed rubble blackstone with cement pointing over a slightly battered plinth; diagonal buttresses with offsets are located to main body of church and steeple. Windows are margin-paned cast-iron diamond lattice lancets with chamfered blocked stone surrounds and sills (unless otherwise stated). East gable faces the road and has a single Decorated tracery window, detailed as others. South elevation is abutted by steeple to right of centre, and has one window to right, three to left. The tower is detailed as church with steep yellow brick spire; it is square on plan rising to an octagonal cement rendered third stage over offset spurs. First stage has (to south), a double-leaf pointed-arched headed timber sheeted door with strap hinges set in chamfered reveal with hood mould and rubble stone voussoirs; window to east; second stage has a central trefoil opening to each face; third stage has a louvred lancet to alternate faces with small aperture to remaining elevations. West gable is completely abutted by hall (see later). North elevation consists of four windows with north porch at right end. Porch has a hipped roof and square-headed timber sheeted door in stop-end chamfered stone reveal to east; north elevation is abutted by later cement rendered lean-to (in poor repair and of little interest); south elevation is abutted by hall. Hall is rectangular on plan, projecting beyond the church by a single bay to south-west. Roof and walling is detailed as church (without buttresses). Windows are paired pointed-arch headed with coloured diamond lattice glazing. Entrance to east consists of pointed-arch headed double-leaf door in projecting surround with stone lean-to roof. Five pairs of windows to west; single window to south gable; north gable abutted by later lean-to (as before); small louvred openings to gable apexes. The church occupies a compact roadside site enclosed by rubble stone boundary walls with soldier coping; accessed from road at east by a pair of cast-iron gates on square piers.

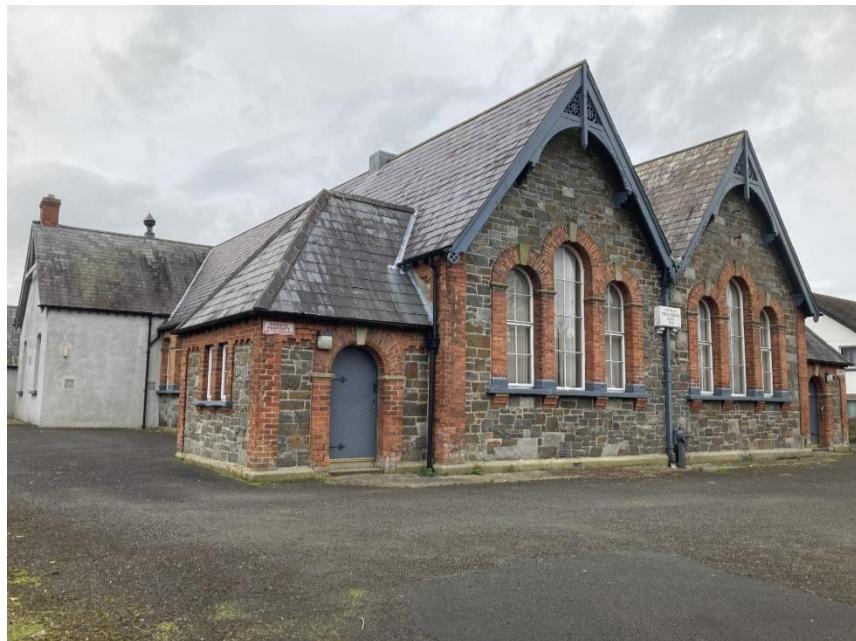
Picture 19 : Old Schoolhouse, now the Presbyterian Church Hall

The old school house is a detached symmetrical two-bay stone building dated 1879 and located on the west side of Melmount Road at the north end of Sion Mills Conservation Area. The school is T-shaped on plan (tail of the 'T' consists of a road-facing double-pile gabled hall) with small return and modern extension to rear and single storey hipped-roof entrance bays to either side. Roof is pitched natural slate with angled clay ridge tiles and ventilation stacks on leaded plinth to ridges; tall brick chimney to rear and further brick chimney to south gable. Decorative painted timber bargeboards to principal gables having carved timber brackets and drop finials. Half-round cast-iron gutters and box downpipes over exposed rafter tails; painted cast-iron water spout to principal elevation. Walling is uncoursed squared rubble (built to courses at porches) over a chamfered stone plinth and having brick quoins; wide brick eaves band with dentil detail extending to window surround. Rear elevation and extension are painted roughcast. Window openings are segmental-headed (unless otherwise stated), with painted masonry sills; all openings have chamfered brick surrounds with moulded stone imposts and keystones, except those to rear, which are plainly detailed. Multi-pane replacement timber casements throughout. Principal elevation faces east and is gabled M-profile with porches slightly recessed to either side. Projecting datestone ("Sion Mills / Public Elementary / School / 1879") is affixed to centre (downpipe passes through centre). Each gable has a triple round-headed window opening (central opening taller) with shared sill on masonry corbels. Each porch has a round-headed door opening containing a replacement diagonally-sheeted timber door with strap hinges accessed by a stone step. Side elevation of each porch has a pair of square-headed windows with shared brick surround and sill; rear elevation blank. South elevation is abutted by the porch at right; rear section projects and is roughcast. Hall section is eight windows wide. Rear section is gabled and has two windows to gable. Rear elevation is abutted by an extension to right and has a return to left of centre. Exposed original elevation has two windows to right of return, three to left; return is blank with the exception of a small square window to rear. North elevation is detailed as south, with the exception of rear block, which is four windows wide

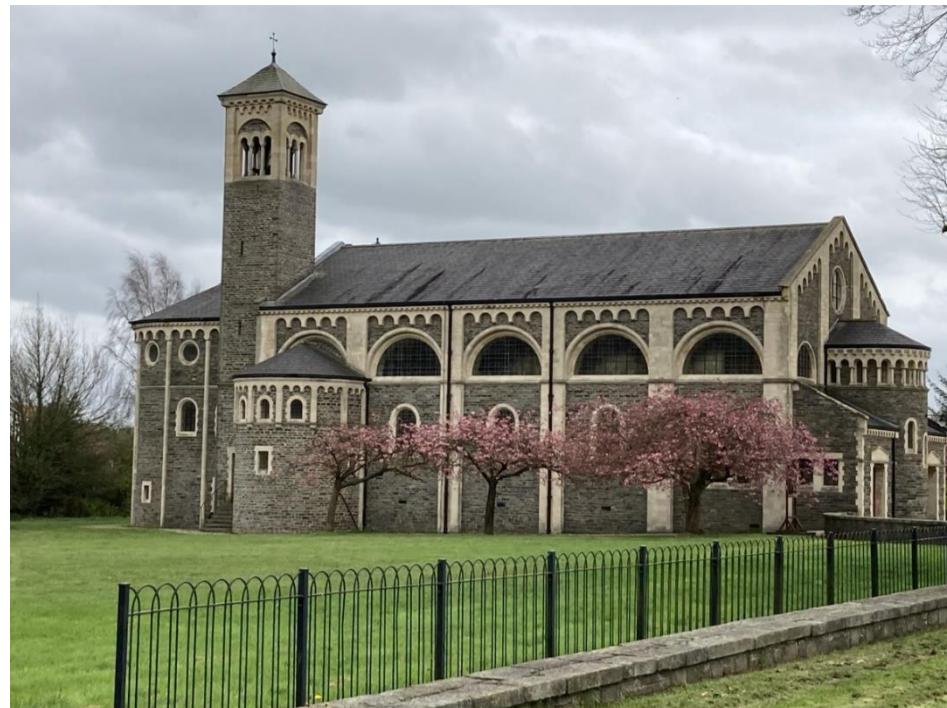
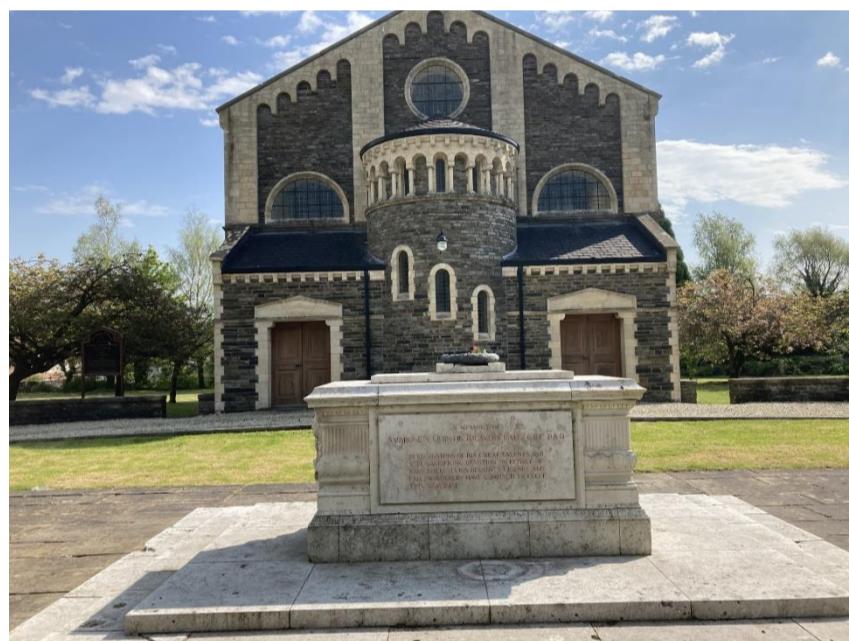
Pictures 21 & 22 : Church of the Good Shepherd and General Ricardo's tomb

The building is a triple height Byzantine style Church of Ireland church, built 1909 to designs by William F. Unsworth, located on the east side of Melmount Road, Sion Mills. The church is rectangular on plan with semi-circular projections comprising a full-height apsidal chancel to east, double-height stair tower to west, double-height store and vestry to north and south respectively; the stair tower is further flanked by lean-to porches and there is a campanile tower to north-east corner. Roof is pitched natural slate, angled clay ridge tiles, stone verges on moulded stone kneelers. Rainwater goods are profiled aluminium over dentilled eaves course. Walling is coursed rubble limestone with ashlar Bath stone dressings. Each elevation (except chancel end) is divided into panels framed by lesene strips with arcaded frieze over (raking to gables). Windows are generally round-headed, all have lattice glazing with lead cames, ashlar surrounds and flush splayed sills. The clerestorey is lit by a continuous series of semi-circular windows (one spanning each panel) with continuous moulded lead-capped sill course. Entrance gable faces west, with central stair tower surmounted by a large circular window, and porches surmounted by a single clerestorey window. Porches are identically detailed, each with stepped ashlar quoins and containing a central square-headed door opening having shallow triangular-headed lintel and deep ashlar reveals; cheeks have a paired rectangular window with central mullion and ashlar chamfered surround. The stair tower has a semi-conical roof over arcaded upper level framed by colonettes (recessed arches are alternately blind and glazed); the main body of the tower contains staggered window openings lighting the stairwell. North elevation consists of five panels, each with clerestorey window. Lower level is as follows: right panel has a tripartite rectangular window; left panel is abutted by store block; remainder each have a round-headed window. Vestry has an arcade over string course at two-thirds height, blind with the exception of two round-headed windows; lower section has small square windows, north by a square-headed door reached by four steps. East end is abutted by the apse to centre and a square tower to left. Chancel has a half-conical roof; walling is divided into panels with string course; upper section has a roundel to each panel, round-headed windows to north and south. Tower has a shallow pyramidal roof and is plainly detailed with loop windows.

The tomb is a classically styled limestone sarcophagus memorial, erected 1923 in memory of Brigadier General Ambrose Quintin Ricardo, and located to the west front of the Good Shepherd Church. The memorial is rectangular on plan, raised on a 3-stage podium. It is classically detailed with cornice, pedestal, and carved framed plaques flanked by corner pilasters having egg-and-dart mouldings and fluted shafts. The memorial is topped by a stepped block finished with a cast bronze wreath.

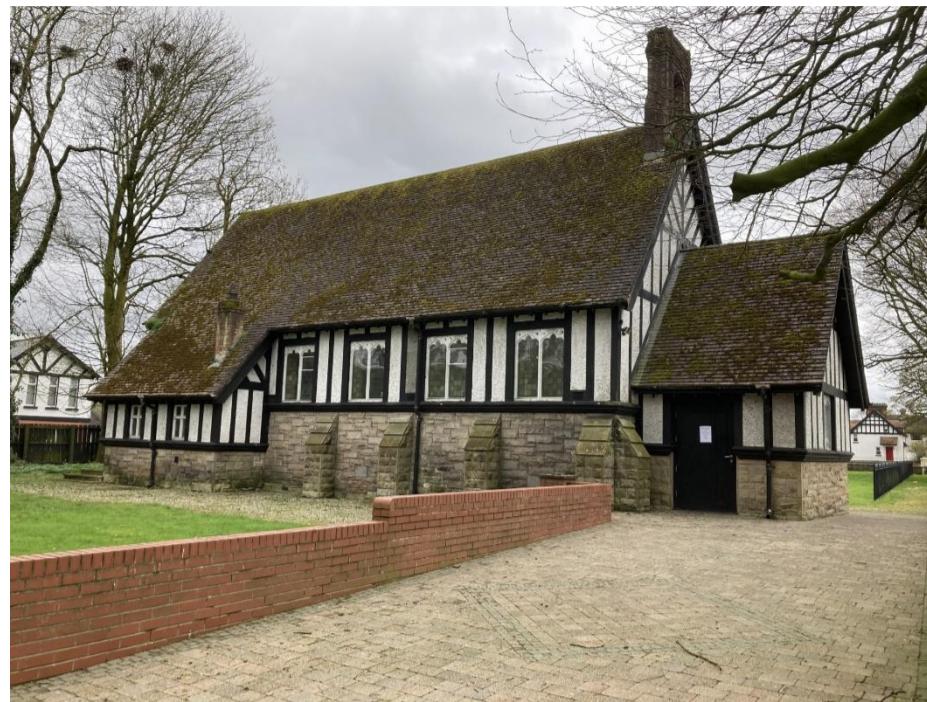
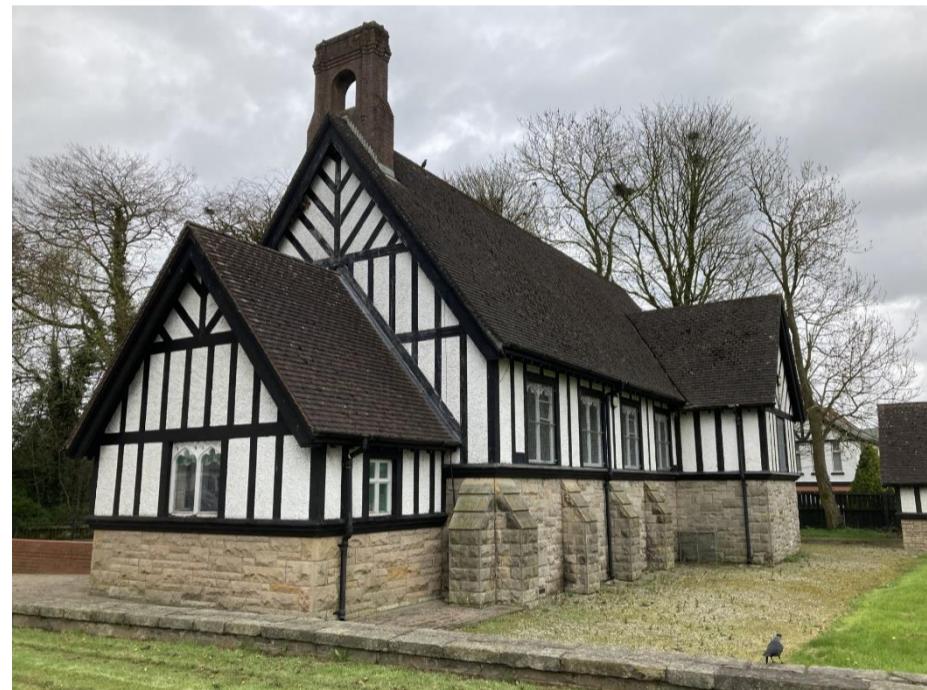
Pictures 23 & 24 : St Savior's Hall

Freestanding single-cell double-height gable-fronted Tudoresque half timbered former church, built c.1895, now in use as a hall and located on a corner site at the east side of Melmount Road within the Sion Mills Conservation Area. Rectangular on plan, with gabled porch to west, small catslide outshot to east, and full height gabled projection to south. Pitched tiled roof with timber eaves-brackets and bargeboards, aluminium rainwater goods. Redbrick chimney stack to catslide projection; redbrick bellcote on western end. Walling is narrow panelled applied half-timbered with rendered infill panels over a high squared rock-faced uncoursed sandstone plinth having sandstone buttresses at regular intervals; angle buttresses at west. Windows to main block are dipartite cusped-headed leaded lattice windows set in square-headed timber frames all have secondary glazing; those to projections are divided by a single timber transom and mullion, replacement leaded glazing; continuous painted lead capped sill course throughout. Principal entrance elevation faces north and consists of four equally-spaced windows with catslide outshot at left end. Outshot has two windows to north and a replacement timber sheeted door to left cheek accessed by three pavoired steps. East gable has quadripartite window, detailed as others (external metal grille over). South elevation has gabled right bay, slightly projecting. Four windows to main section, one window to gable. West gable has a diminished gabled extension with central window; transomed and mullioned window to right cheek; hardwood sheeted door to left cheek. Setting: The former church is set slightly back from the road on an open plot and surrounded by paved perimeter paths; there is a lawn with single-storey shed (constructed in similar style) to southeast. Bounded to west by a low stone wall and to the north by a low red brick wall with iron railings; red-brick gate piers with decorative concrete cap; timber gate with metal knob. Accessed

from the road at north via a painted timber pedestrian gate supported on red brick piers. Situated to the southeast is the replacement church, The Church of the Good Shepherd

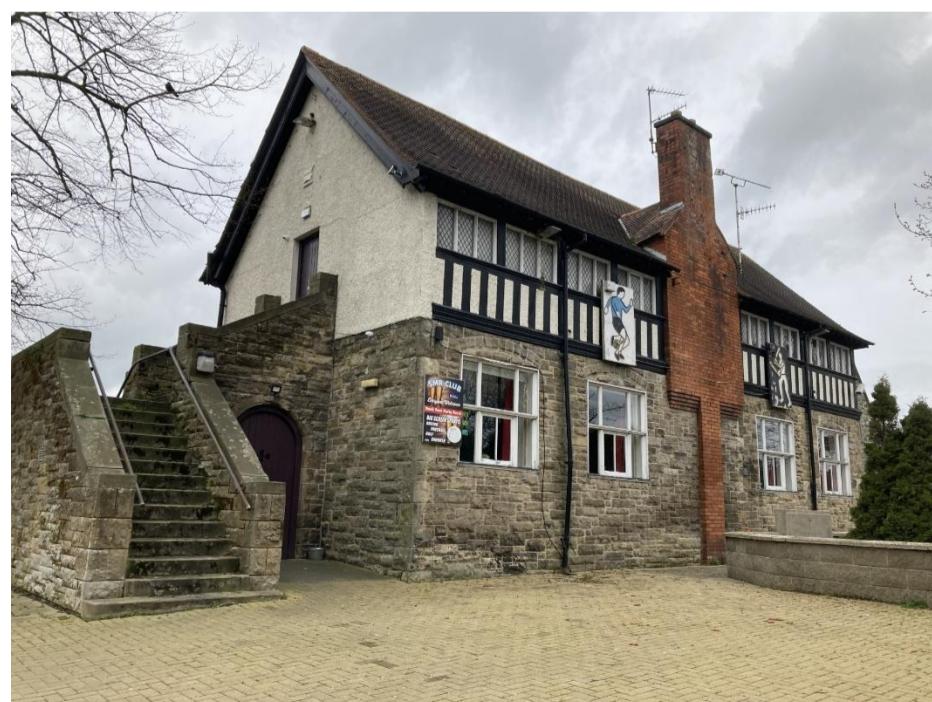
Picture 25 : The Working Men's Institute

Detached multi-bay two-storey stone and applied timber frame former Working Mens' Institute, built c.1895, now known as Sion Mills Recreational Club. Rectangular on plan, facing east on the west side of Melmount Road with external stone stair to south gable and flat-roofed rear extension. Pitched terracotta tiled roof with roll-moulded terracotta ridge tiles, sprocketed eaves with exposed rafter feet and timber bargeboards to the gables. Steel rainwater goods to rafter feet. Random coursed rock-faced sandstone ashlar walling to ground floor and staircase, with continuous moulded timber course and timber-framed to upper floor with pebbledash rendered panels. Symmetrical multi-bay two-storey front elevation, four square-headed window openings to ground floor with stone relieving arches and timber casement windows with lead-lined timber sills; series of tripartite timber casement windows to first floor with leaded glazing and some steel casements. To the centre of the front elevation is a large redbrick chimneystack laid in Flemish bond, projecting beyond the stone wall as a narrow flue to the ground floor, corbelled out in redbrick and forming a large blind breakfront to the first floor before narrowing again as a chimney above the roof. South gable is pebbledash rendered above ground floor and is abutted by an external stone staircase, built on a T-plan in random course rock-faced sandstone ashlar with tooled stone ashlar coping and concrete steps. Steps lead to a single door opening to the first floor with vertically-sheeted timber door. Below the steps at ground floor level is a round-headed door opening with voussoired stone arch and vertically-sheeted timber door. Rear elevation is abutted by a large flat-roofed extension having decorative single-pitched terracotta tiled canopy. Ten tripartite windows with leaded lights are visible to the first floor with the continuous timber sill and timber framed wall below. Gable-ended north elevation has a large landscape window opening to both floors with timber casement windows having leaded lights. Random coursed rock-faced sandstone ashlar walling to ground floor with continuous moulded timber course and elaborate timber frame and pebbledash rendered finish to first floor and gable with overhanging eaves and carved timber barge-board. Set back from the road with a paved front area enclosed by a low rubblestone wall with stacked coping, continued to the north of the site forming the boundary between the Club and the Church

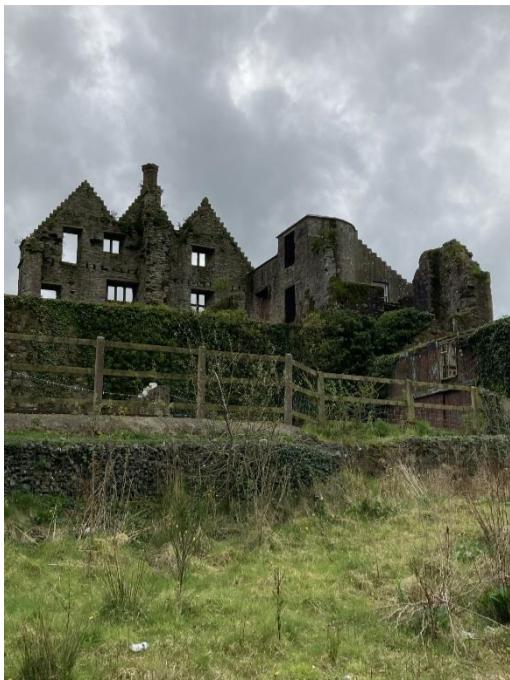
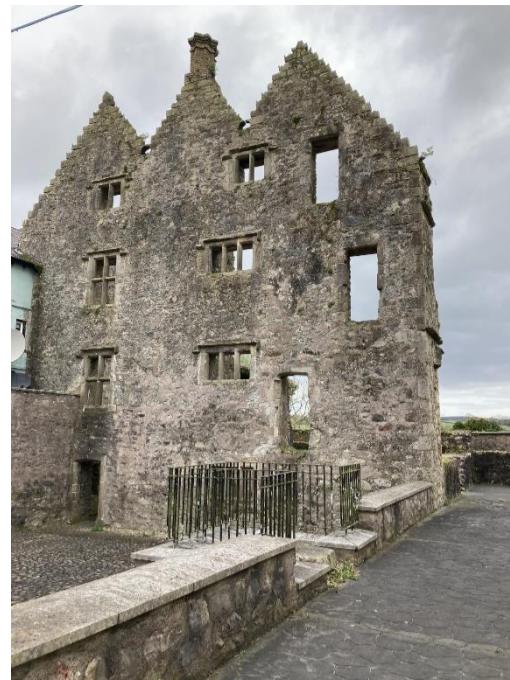
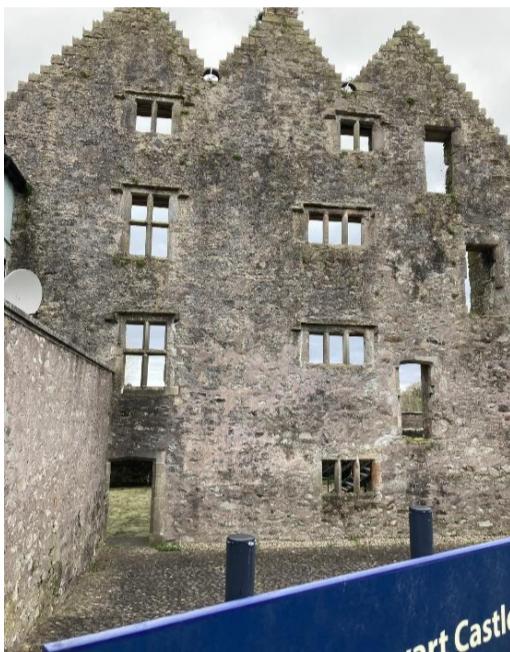
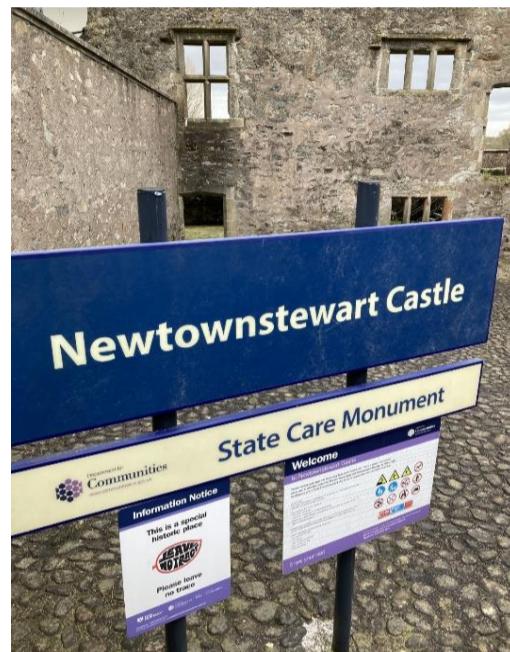
Pictures 26 – 29 : Newtownstewart Castle

Built in 1619 on the site of an older edifice by Sir Robert Newcomen & described in the 1622 survey as "a Castle of lyme & stone of good strength, 4 stories high..." It is similar to contemporary English Manor houses, with little defensive equipment. It was burned in 1641, then rebuilt. It was occupied for a night by James II in 1689 on his return from the Siege of Derry and was dismantled on his orders the next day. Excavations on the site in 1999 recovered four large burnt posts from the doorway in the east curtain wall, which have been dendro-dated to 1616/1617.

The site is currently locked with no access. Discussions are commencing between HED and the local community with regard to keyholding arrangements. Once this has been agreed then access can be promoted.

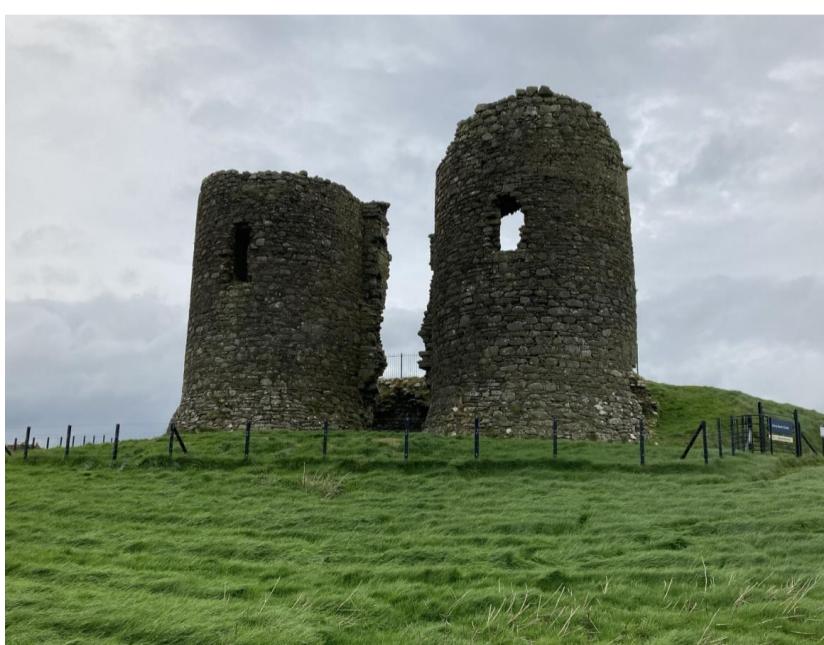
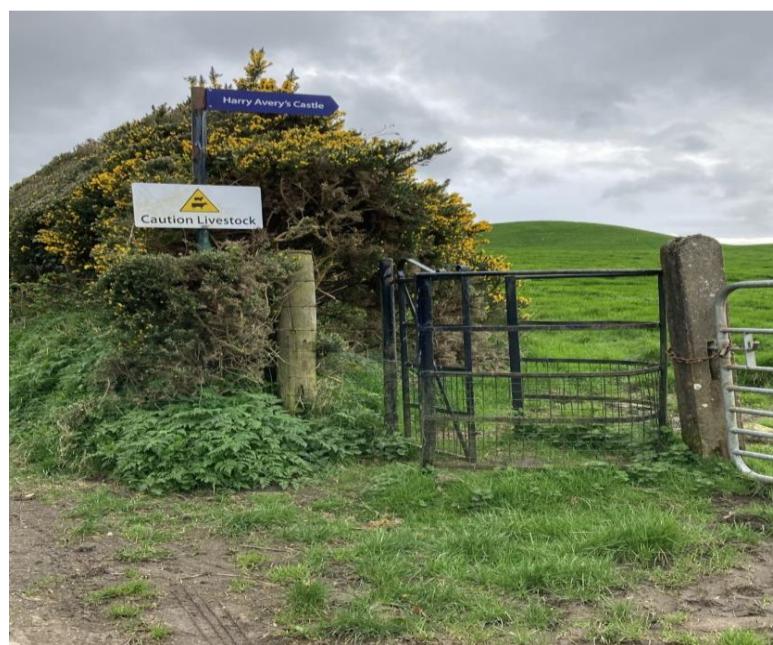
Picture 30 (Harry Avery's Castle) and Picture 31 (Signage and Pedestrian Access Gate)

The site is on a prominent hill commanding important river routes 1.2 km south-west of Newtownstewart. It is named after Henry Aimbreidh O'Neill, who died in 1392, and dates to the 14th century as excavation revealed a 14th century window head. It is one of the few native built stone castles in Ireland. An artificially scarped natural mound formed an elevated ‘bailey’ or courtyard surrounded by a polygonal curtain wall with at least two projecting towers, all now ruined to a low level. At its south-west end is a tower that looks like a gatehouse defended by a bridge pit and entered between high D-shaped towers, but the only way into the courtyard behind was up a stair and through the hall at first floor level.

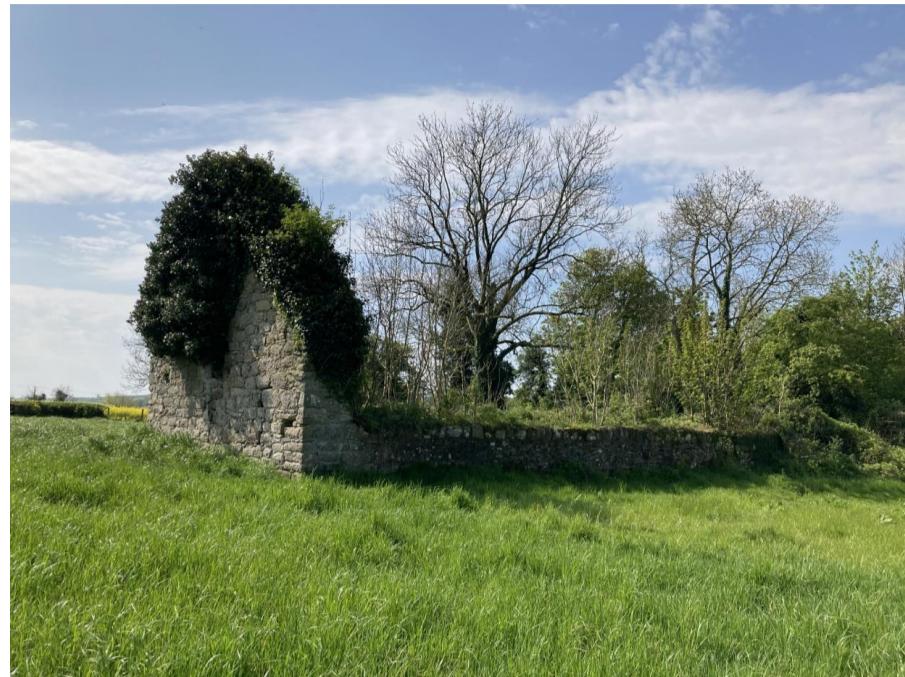
Picture 34 : Ruins of Camus Church

The post-medieval church & graveyard have been cut through by the now disused railway line. The church is orientated east to west. The east gable survives to almost full height. The oldest legible gravestone in this graveyard is dated 1742.

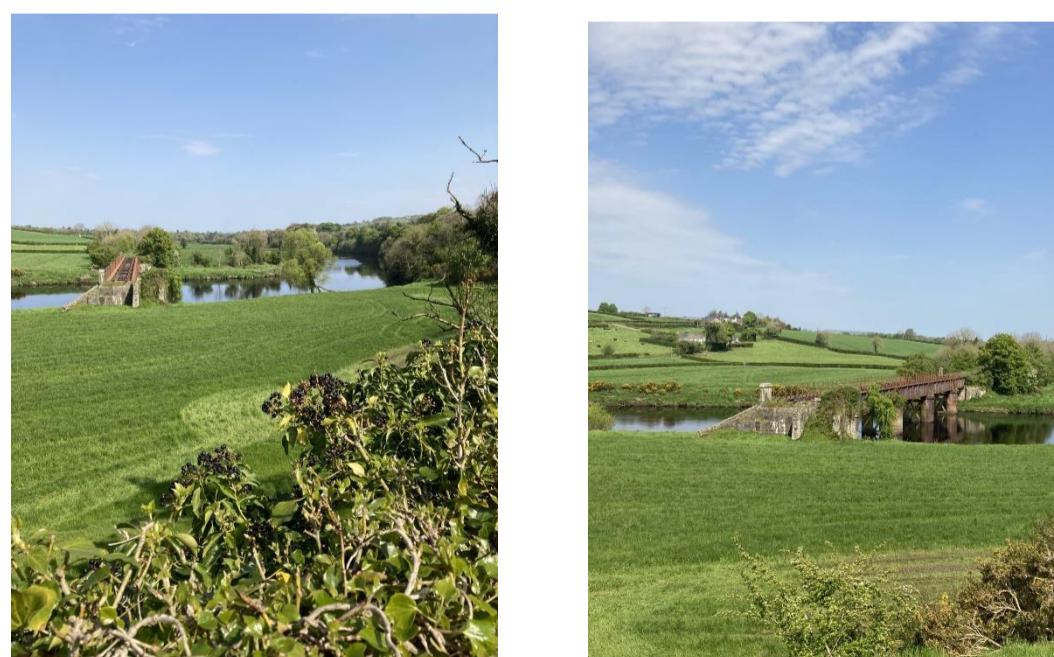
Pictures 36 & 37 – Railway Bridge at Camus (offering a possible connection with the Mourneside walk from Sion Mills)

The access lane to Camus Church and Graveyard from Lisky Road is an uneven farm lane, more suitable for agricultural vehicles than private cars, the legal public access on this laneway is undetermined. There may be a possibility of including Camus Church and Graveyard as part of the potential extension to the Mourneside walk from Sion Mills to the Railway Bridge at Camus which is one field length from the old church, see photos above. The site is currently maintained by DCSDC.

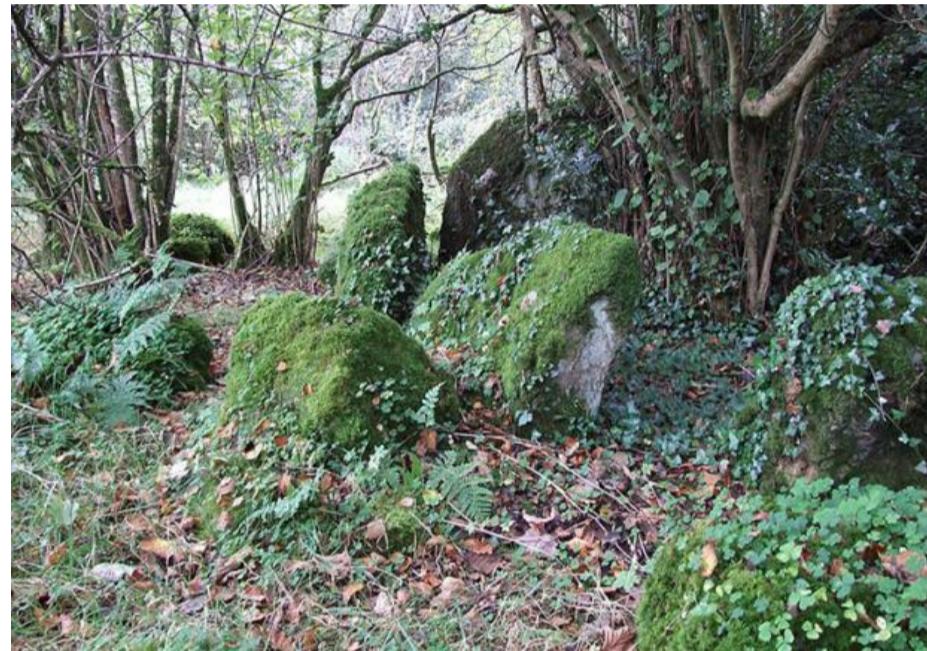
Picture 38 : Lisky Court Tomb

On a rocky knoll on the north bank of the Mourne River lies a court tomb chamber. Despite a dense covering of trees & bushes, the site survives aligned east-west consisting of a split boulder backstone to the east and four slabs set two on either side forming the chamber walls. Six very large stones make up a long chamber running east-west, with a low stone sill closes the west end of the chamber. This is probably the remains of a court tomb, but without excavation the original form is uncertain. Court tombs, also known as 'horned cairns' have been dated by archaeologists to have been used between 3800 BC and 2500 BC. Court tombs are so called because they incorporate in their structure a ritual roofless court. The area of this court is usually marked by a wall constructed of upright stones. The cairn covered the chamber and filled the area between the kerbs, the front of the chamber and the court. Court tombs were generally built with their entrances facing east. The most common method of burial in court tombs was cremation. There are over three hundred and ninety known court tombs in Ireland and these occur almost exclusively in the northern half of the island.

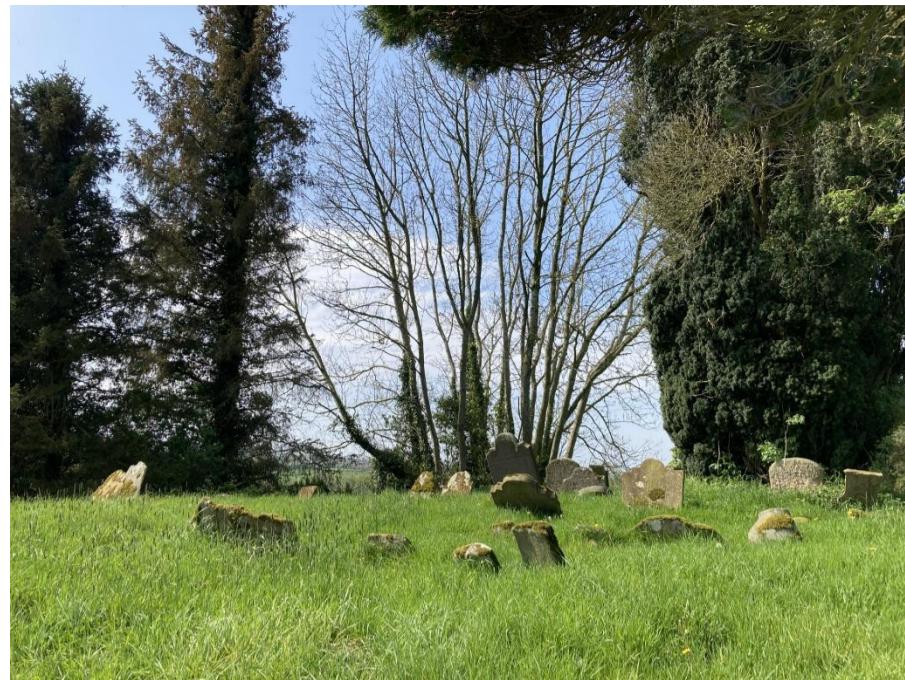
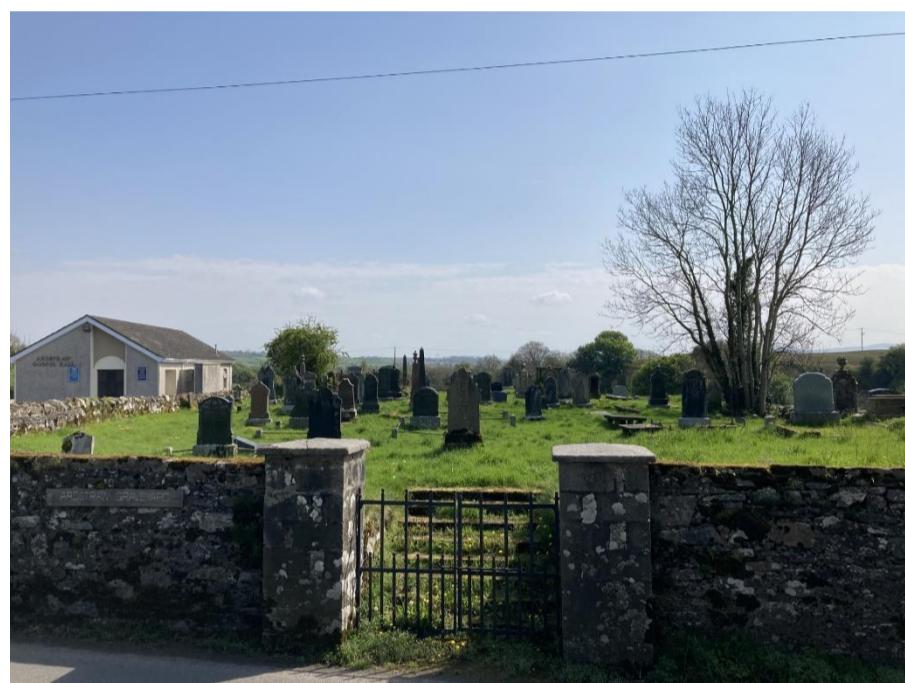
Picture 40 & 41 : Ardstraw Monastery & Graveyard (located either side of a narrow road at the entrance to Ardstraw)

The monastery and graveyard are located at the entrance to Ardstraw village, either side of the road. There is parking for approximately one or two cars with access gates and interpretative boards on site. The site is currently maintained by DCSDC.

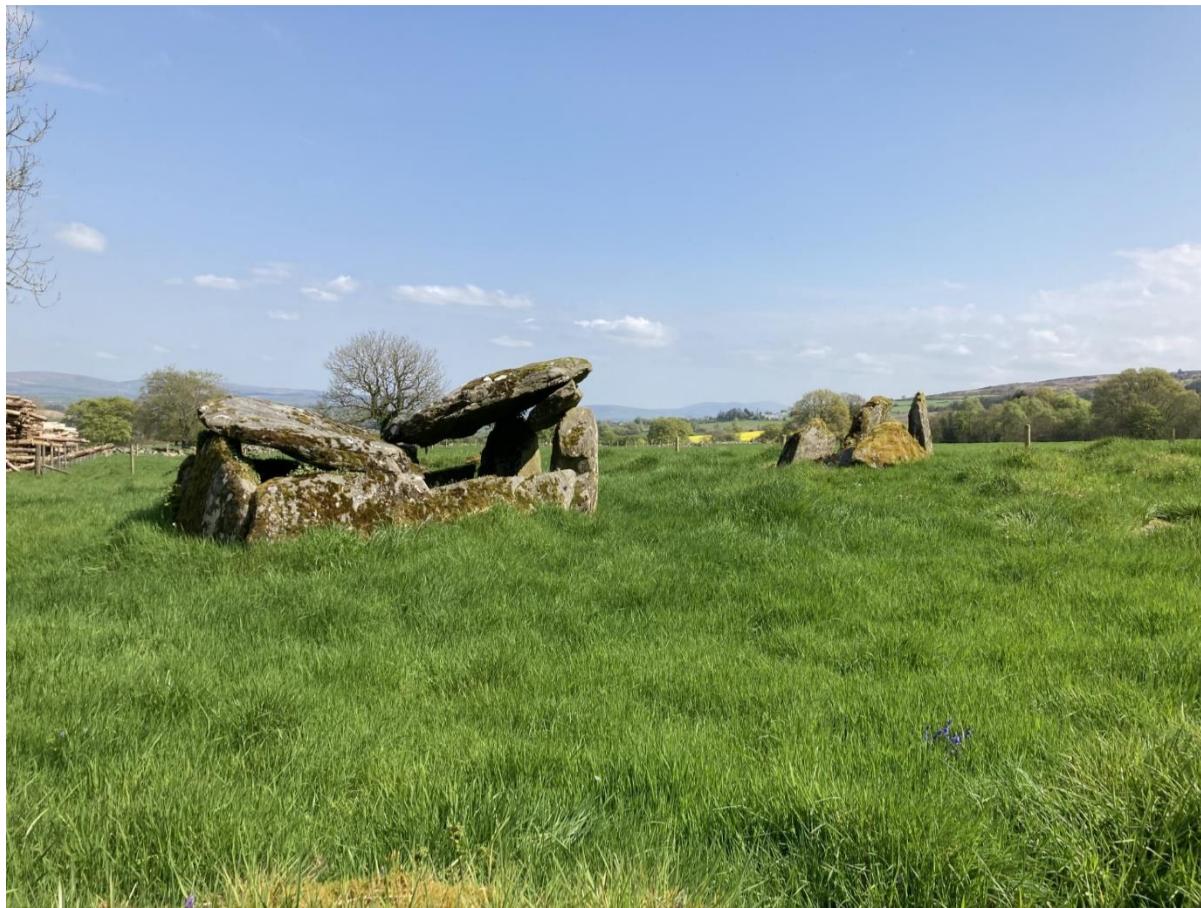
Picture 42 : Ballyrenan Portal Tombs

The remains of two megalithic tombs are evident at Ballyrenan. To the east of the site a single portal tomb stands with the portals and side stones intact, however, the capstone is no longer evident. To the west stands a double portal tomb of which the western tomb appears intact. The eastern tomb has a pair of side stones and a lintel over the entrance. All of this is surrounded by cairn material. When excavated in 1907, a flint arrowhead & stone beads were found. Further excavations in 1936 uncovered sherds of at least four Neolithic pots, worked flints & beads. Two of the capstone are decorated with a series of well-formed cup-marks on their upper surfaces. There are almost two hundred portal tombs in remaining in Ireland. They are easily the most clearly recognisable type of Irish megalithic monument. Portal tombs are generally classified by a kind of entrance feature, the 'portal' or doorway opening into the burial chamber. This portal or entry is often found closed by a blocking stone. The most characteristic feature of a portal tomb is the massive capstone or roofstone, often weighing tens of tons and usually inclined at an angle with the highest portion over the entrance or portal. Archaeologists have dated portal tombs to c4000BC – c3000BC.

HED have confirmed that this monument is not currently a State Care Monument and is in private ownership and scheduled for protection. As such there is no public access at present.
