Newtownstewart and Sion Mills- Heritage Audit

Heritage Tourism and Environmental Consultants (HTE) have been commissioned by Derry City and Strabane District Council to undertake a heritage audit of the settlements of Sion Mills and Newtownstewart, Co .Tyrone.

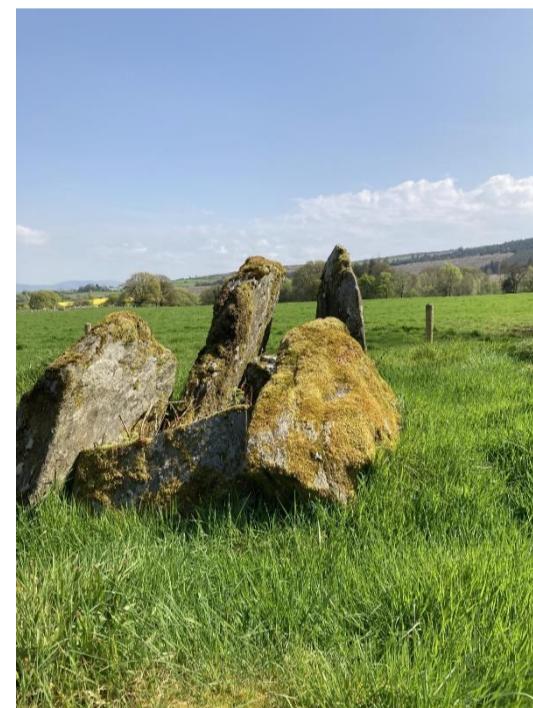
Pictures 43 and 44 : Portal Tombs at Ballyrenan.

The remains of two megalithic tombs are evident at Ballyrenan. To the east of the site a single portal tomb stands with the portals and side stones intact, however, the capstone is no longer evident. To the west stands a double portal tomb of which the western tomb appears intact. The eastern tomb has a pair of side stones and a lintel over the entrance. All of this is surrounded by cairn material. When excavated in 1907, a flint arrowhead & stone beads were found. Further excavations in 1936 uncovered sherds of at least four Neolithic pots, worked flints & beads. Two of the capstone are decorated with a series of well-formed cup-marks on their upper surfaces. There are almost two hundred portal tombs in remaining in Ireland. They are easily the most clearly recognisable type of Irish megalithic monument. Portal tombs are generally classified by a kind of entrance feature, the 'portal' or doorway opening into the burial chamber. This portal or entry is often found closed by a blocking stone. The most characteristic feature of a portal tomb is the massive capstone or roofstone, often weighing tens of tons and usually inclined at an angle with the highest portion over the entrance or portal. Archaeologists have dated portal tombs to c4000BC – c3000BC.

HED have confirmed that this monument is not currently a State Care Monument and is in private ownership and scheduled for protection. As such there is no public access at present.

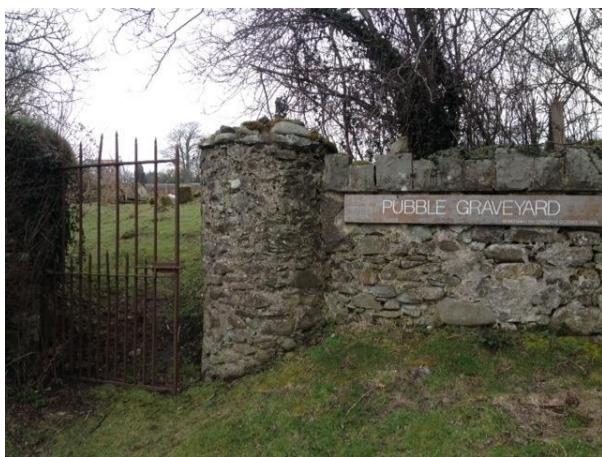
Picture 45 : Entrance to Pubble Graveyard.

The site is accessible from a public layby adjacent to the A5. The site is maintained by DCSDC with some health and safety repair works planned to be carried out to the entrance gate. The site itself is quite steep with an uneven surface and trip hazards and therefore not suitable for all.

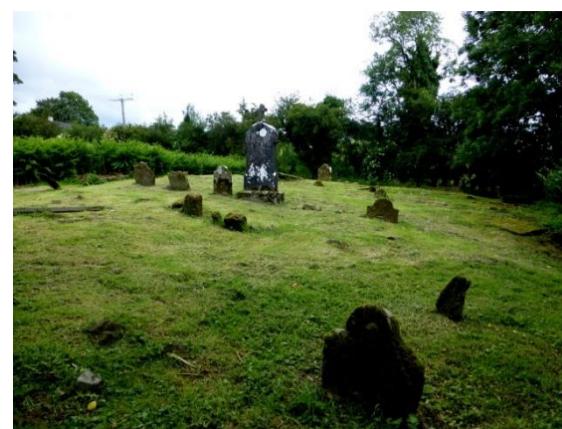
Picture 46 : Pubble Graveyard

Located immediately off the Beltany Road stands the remains of a late medieval Franciscan Friary and graveyard. There are no visible remains of the abbey, which was founded by Franciscans (3rd Order) in the 15th Century. The graveyard consists of a rectangular walled enclosure. The interior is split level, which may relate to an internal structure.

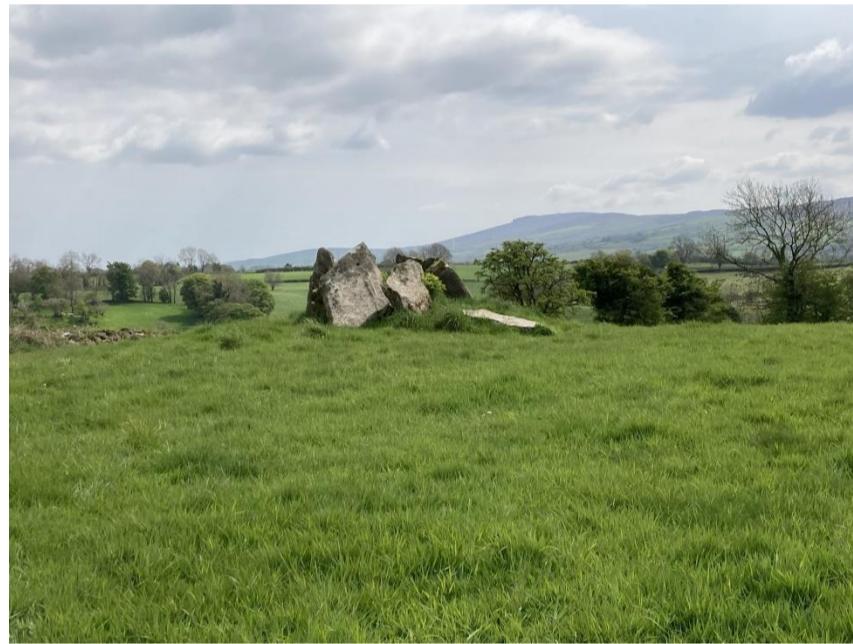
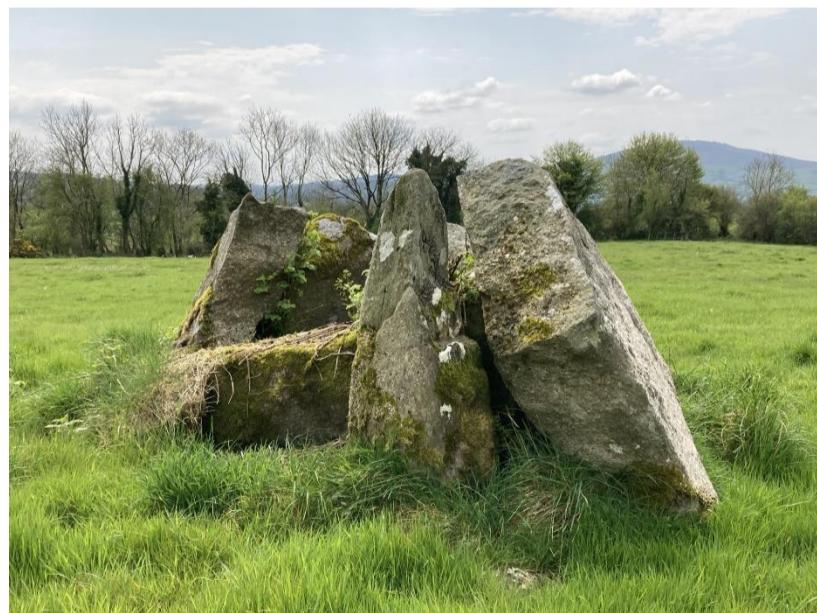
Pictures 47 & 48 : Glenknock Portal Tomb

Located 2.4 km north-east of Newtownstewart east of the minor road leading north off the B46 (Plumbridge) road at St Eugene's church. The megalith is disturbed but among the leaning stones it is possible to detect two portal stones at the north-west and a back stone. The capstone is shattered into five pieces and there are many field stones now set at the monument. The site is named "Cloghogle", meaning raised stone.

HED have confirmed that while there is public access to State Care Monuments this access can be closed at any times on health and safety grounds by government or the landowner. At present there is no right of way to Glenknock Portal Tomb.

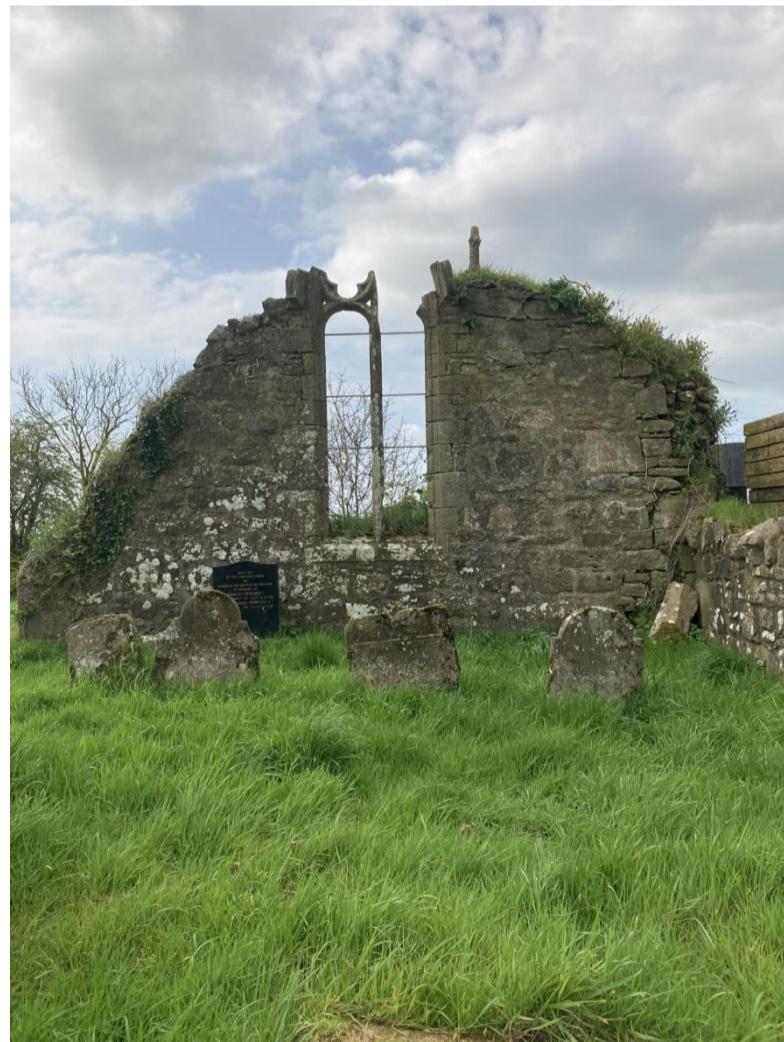
Picture 50 : Gable wall of Corick Abbey

A religious foundation has existed here since the 6th century. The present ruins are of a Franciscian (3rd Order) Friary established in the 15th century. It is beautifully situated at the end of a low ridge near the confluence of the Owenkillew and Glenelly rivers.

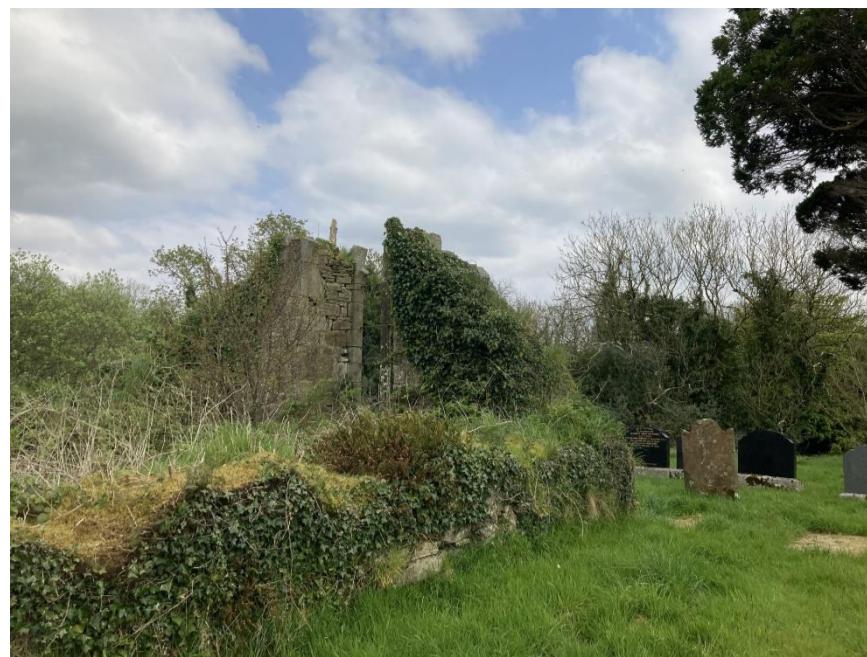
Picture 51 : Corick Abbey & Graveyard

Located off the Newtownstewart to Plumbridge road the site is accessed down a long access lane (there is currently no directional signage from the main road) which has been adopted by DFI roads service approximately 620m, up to the farm yard bitmac surface just before the graveyard entrance. The site is located adjacent to a working farm yard and the gable wall of the Abbey is structurally unsound potentially being a health and safety hazard. The site is currently maintained by DSCDC who have plans to carry out some improvements to the site in terms of access.

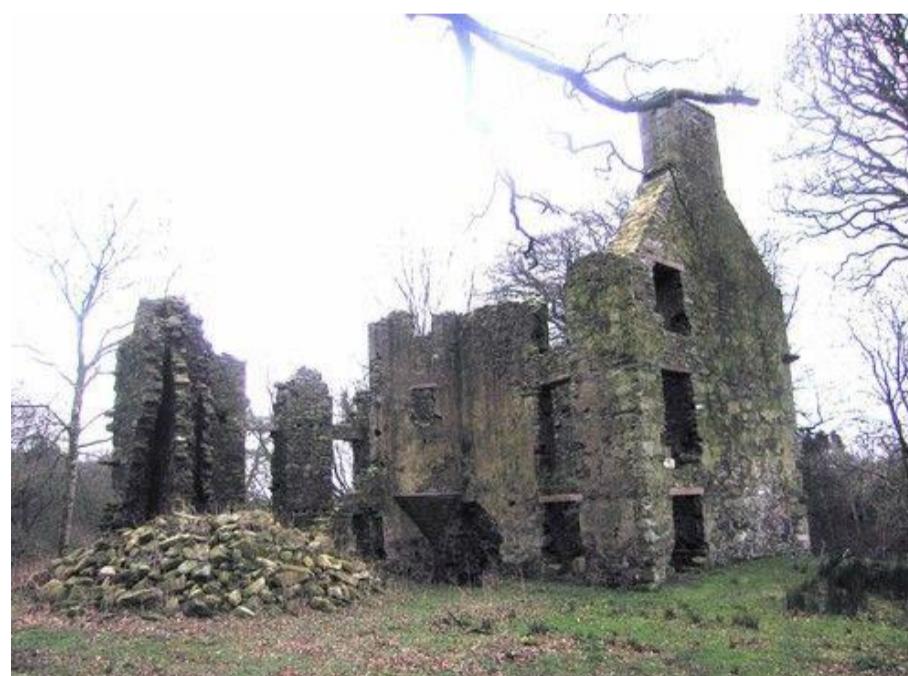
Derrywoon Castle is a Plantation Bawn originally built in 1622 by Sir George Hamilton of Greenlaw, brother of the James Hamilton the first Earl of Abercorn. Derrywoon castle and its environs are located within Baronscourt Estate in an undulating landscape surrounded by woodland and overlooking Lough Catherine which is to the west. The demesne is bound, c. 100m to the east of the castle, by Golf Course Road which also forms the boundary between Baronscourt and Ballyrenan townlands.
